**DEPARTMENT OF TRANSPORTATION**

Contract #: 04-0120F4Cty: SF/ALA Rte: 80 PM: 13.2/13.9File #: 1.28**WELDING INSPECTION REPORT****Resident Engineer:**Siegenthaler, Peter**Address:** 333 Burma Road**City:** Oakland, CA 94607**Report No:** WIR-026119**Date Inspected:** 17-Aug-2011**Project Name:** SAS Superstructure**OSM Arrival Time:** 700**Prime Contractor:** American Bridge/Fluor Enterprises, a JV**OSM Departure Time:** 1730**Contractor:** American Bridge/Fluor Enterprises, a JV**Location:** Job Site**CWI Name:** Steve Mc Connell**CWI Present:** Yes No**Inspected CWI report:** Yes No N/A**Rod Oven in Use:** Yes No N/A**Electrode to specification:** Yes No N/A**Weld Procedures Followed:** Yes No N/A**Qualified Welders:** Yes No N/A**Verified Joint Fit-up:** Yes No N/A**Approved Drawings:** Yes No N/A**Approved WPS:** Yes No N/A**Delayed / Cancelled:** Yes No N/A**Bridge No:** 34-0006**Component:** SAS Tower**Summary of Items Observed:**

# WELDING INSPECTION REPORT

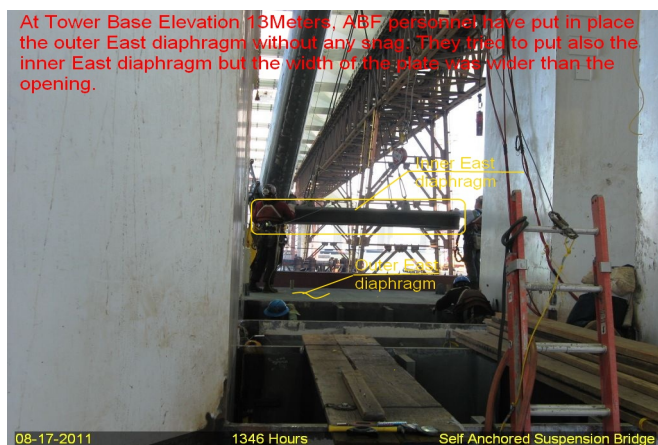
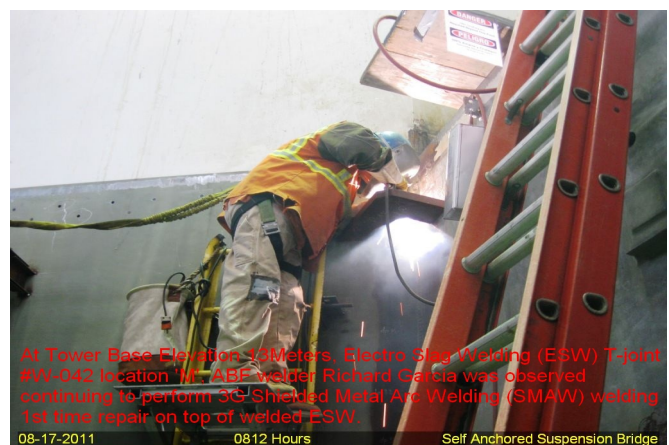
At Tower Base Elevation 13Meters, Electro Slag Welding (ESW) T-joint W-042 location 'M', QA randomly observed ABF/JV qualified welder Richard Garcia continuing to perform CJP groove welding repair on the top 165mm to 315mm of the vertical welded ESW due to detected defect from Ultrasonic Testing (UT). The repair was previously excavated using carbon air arc gouging then ground smooth using a die grinder. The excavation was also tested using Magnetic Particle Testing ( MT) by ABF QC Steve Mc Connell and verified by this QA with affirmative result.

ABF/JV qualified welder Richard Garcia was observed in the 3G (vertical) position utilizing Shielded Metal Arc Welding (SMAW) with 1/8" diameter E7018H4R electrode implementing welding procedure ABF-WPS-D15-1000-Repairs. The weld repair was preheated to more than 300 degree Fahrenheit using propylene gas torch prior welding. During the shift, ABF QC Steve Mc Connell was noted monitoring the welder. Measured welding parameter during welding was 133 amperes on a 1/8" diameter E7018H4R electrode. Before the end of the shift, welding repair on the opposite side of the ESW excavation was completed and was visually checked by ABF QC Steve Mc Connell and this QA. According to QC, he will wait for 48 hours cooling period and then perform the required MT and UT.

welder Jeremy Dolman perform 3G SMAW first time welding repair (R1) on the Ultrasonic Testing (UT) detected defect on the vertical weld of the ESW. The welder was observed welding in the 3G (vertical) position utilizing Shielded Metal Arc Welding (SMAW) with 1/8" diameter E7018H4R electrode implementing welding procedure ABF-WPS-D15-1000-Repairs. The boat shape repair located at Y=9450mm was excavated to dimensions of 170mm long x 75mm wide x 40mm deep. The excavation was previously tested using Magnetic Particle Testing (MT) by ABF QC John Pagliero and fellow QA Danny Reyes. The repair excavation and the adjacent base metal was preheated to more than 300°F using propylene gas torch prior welding. During the shift, ABF QC Steve Mc Connell was noted monitoring the welder. Measured welding parameter during welding was 130 amperes on a 1/8" diameter E7018H4R electrode. At the end of the shift, 3G repair welding was still continuing and should remain tomorrow.

At Tower Base Elevation Electro Slag Welding (ESW) T-joint #E-041 location 'R', ABF welder Richard Garcia was noted excavating the weld cover underfill that was visually noted after the ESW. The welder was using carbon air arc gouging the ESW vertical weld 1450mm from the base plate. During conversation with Caltrans Engineer Doug Wright, this QA had asked whether a Repair Weld Request (RWR) would be necessary since it is an ESW. Mr. Wright told this QA that the RWR will not be required since it is an external visual defect but added that it should be documented.
